# Metals and Cheeses: Unconventional Pairings

Lecture 8

22.033/22.33 – Nuclear Engineering Design Project

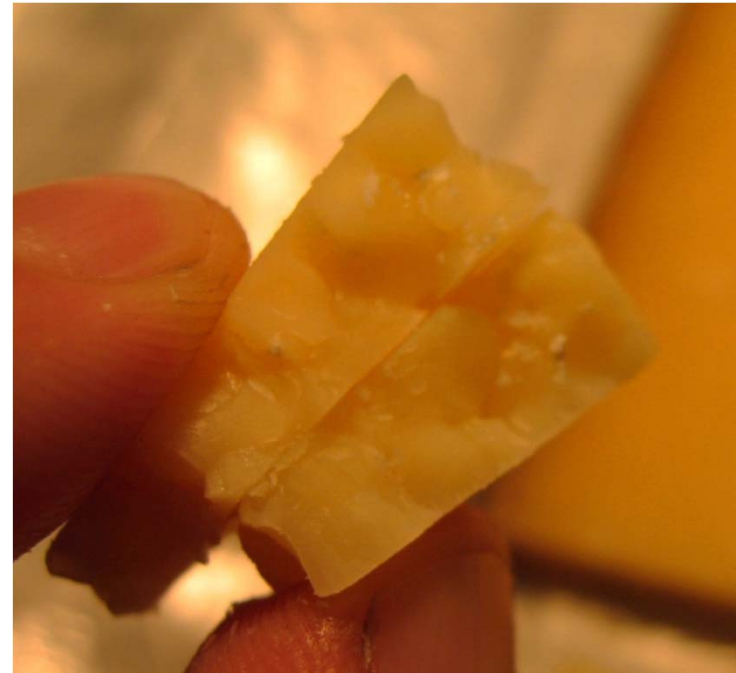
**IG fracture of Cabot cheddar cheese,  
showing matching fracture surfaces**

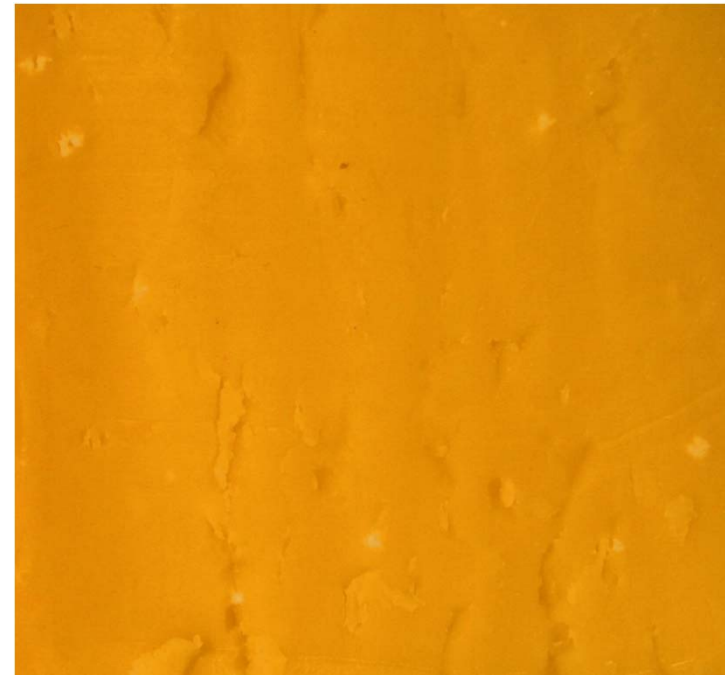
**Lactic acid SPPs on the cut surface of Comté cheese**

Comté cheese has lactic acid SPPs

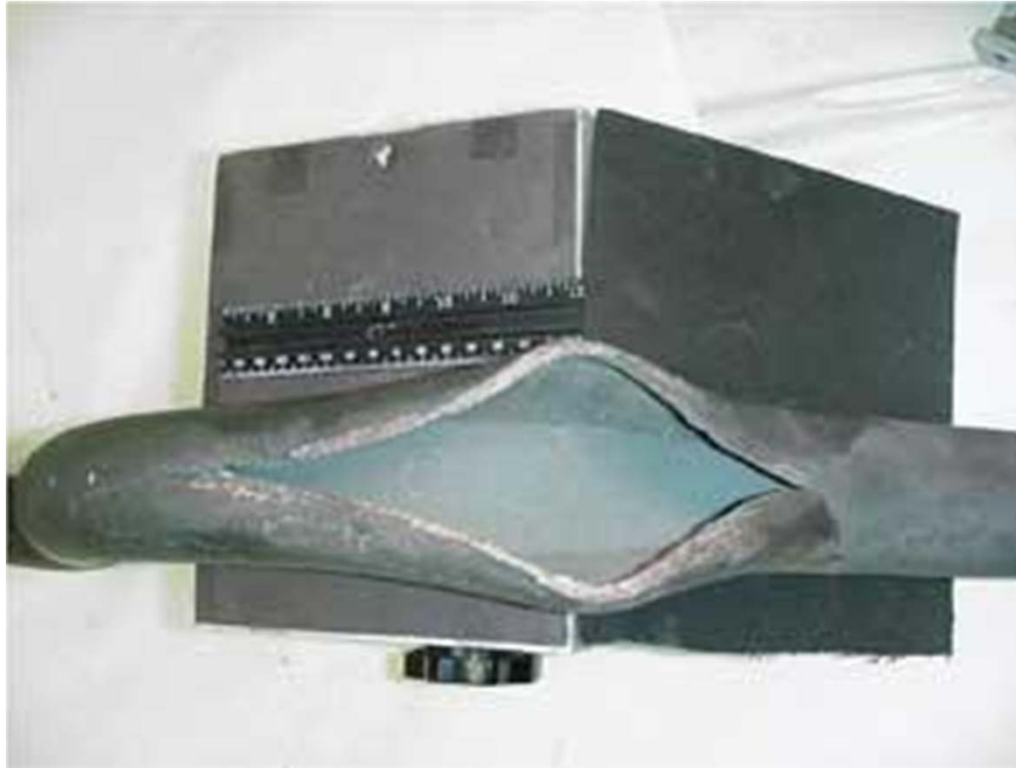
## **Creep failure in T91 pipe due to prolonged heat treatment and oversoftening**

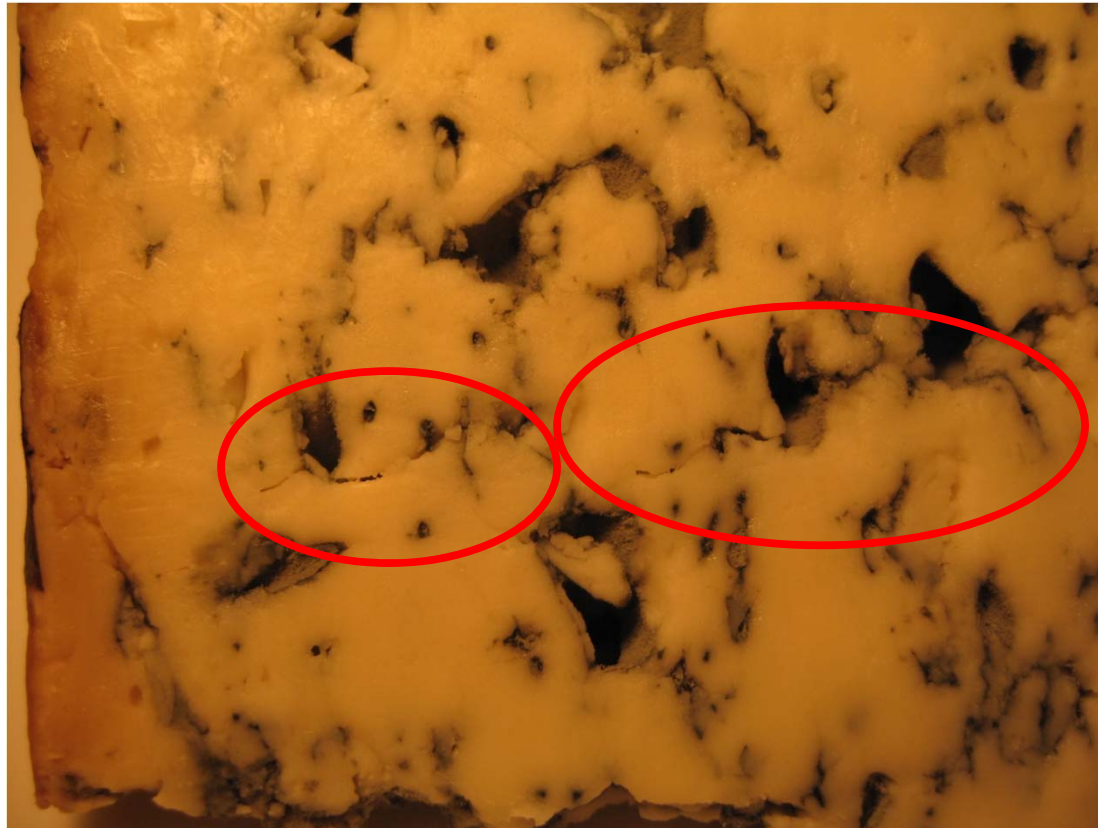
**Note regions of intercurd attack by mold, exhibiting “sensitization-like” behavior**
